*Airfield Damage Repair Modernization Program*

## **AM2 Modified 2-1 Lay Pattern Evaluation under F-15E Traffic**

August 2015

Final report

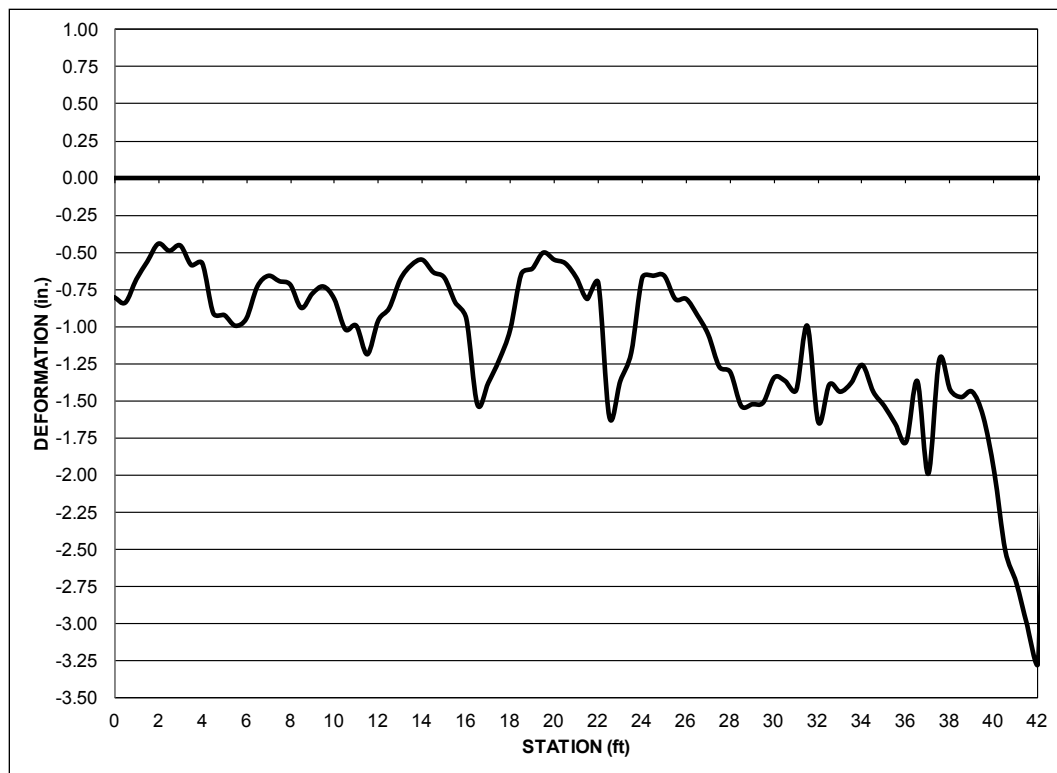
Figure 32. Subgrade centerline profile after 2,850 passes.

The pre-traffic data were subtracted from all subsequent data collected after trafficking began to normalize the data and show only the changes caused by trafficking. Plots of the centerline profile data, as determined from robotic total station recordings, are shown in Figures 32 and 33. When determining the maximum roughness value in each item, boundary conditions were ignored (i.e., first and last two stations along the centerline in Figures 32 and 33). This was done because of the different properties at the interface of the test section subgrade and the stronger surrounding material. Stations 16, 22, and 31 to 38 were areas of panel end connector rail failure, severe skin tears, or core crushing, and are represented as deep depressions in the subgrade and the mat surface. These were disregarded when analyzing the profile, since they were associated with mat breakage and not necessarily with the system's ability (or inability) to prevent excessive roughness.

Pass number	1,008	2,032	2,850
Subgrade profile max abrupt change in elevation (in.)	-	-	0.46
Mat surface profile max abrupt change in elevation (in.)	0.17	0.19	0.13
Subgrade permanent deformation (in.)	-	-	1.74*
Loaded deformation on mat surface (in.)	0.74	1.01*	1.34*
Unloaded deformation on mat surface (in.)	0.20	0.32*	0.66*

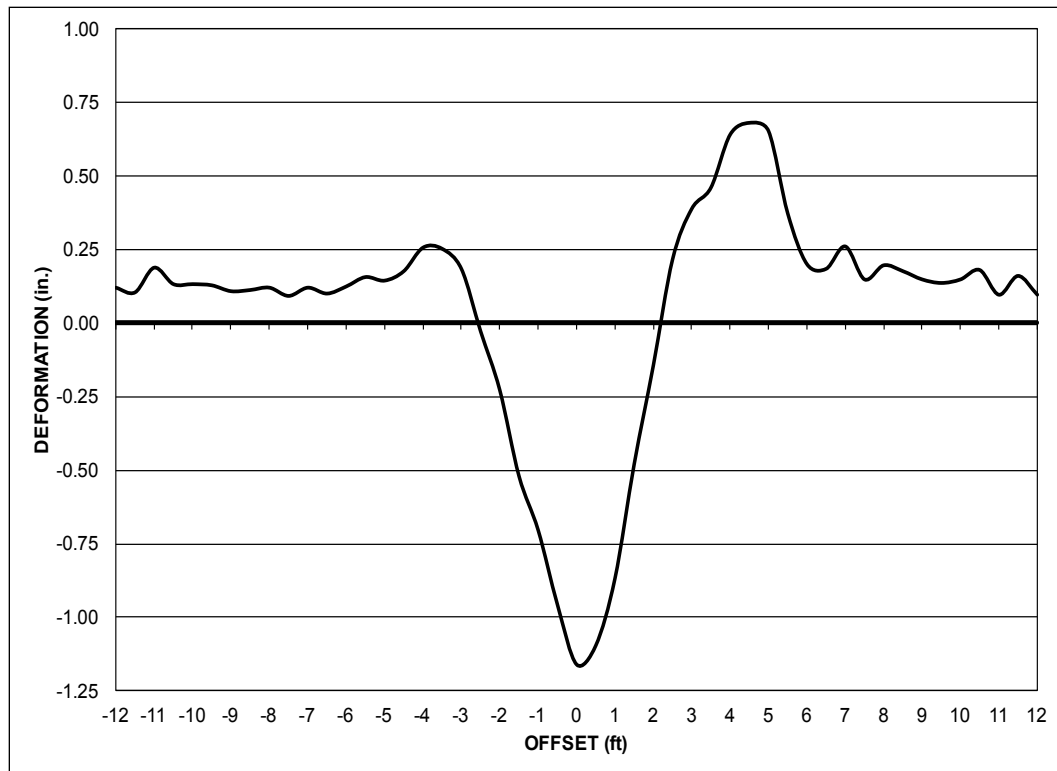
Figure 34. Average deformation on the subgrade after 2,850 passes.

Plots of the average cross-section elevation data, collected along lines A1, A2, and A3, are shown in Figures 34-36. Table 9 summarizes important deformation values determined from all the plots for comparison to the failure criterion. Note that after failure of panel J46, which was located at cross section A2, material rearrangement and buildup occurred beneath and around line A2. This affected any data collected along line A2 for the remainder of the test, giving an unrealistic measure of the deformation on the mat surface and the subgrade. Therefore, measurements shown in Figures 34-36 after pass 1,644 were the average of data collected along lines A1 and A3.

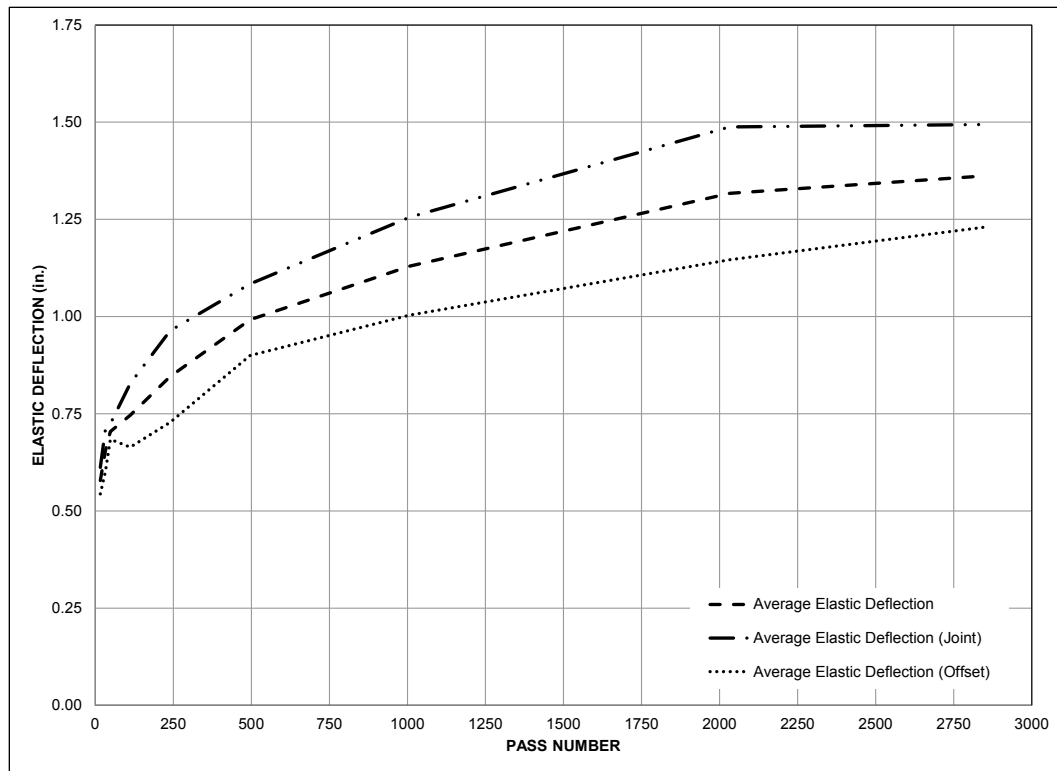
Figure 37. Elastic deflection.

The difference between the loaded (immediately adjacent to the tire of the load cart) and the unloaded elevations at the locations shown in Figure 21 represents the elastic deflection, or rebound, of the mat and the subgrade at each location. The measurements determined from readings taken at the quarter point (3 ft from end) of the three panels were averaged to give a final elastic deflection value. The same was done for measurements determined from readings taken at three joints. The average of these two values was also calculated. One number was reported for each condition at each pass level in Table 7. The results are shown in Figure 37. Note that measurements after pass 1,644 (failure of J46) represent the average of data collected near stations A1 and A3.
